When Air Leaks In, Quality Leaks Out.

OneVision Corporation is a leading supplier of can seam inspection and measurement systems.

All-In-One SeamMate® System

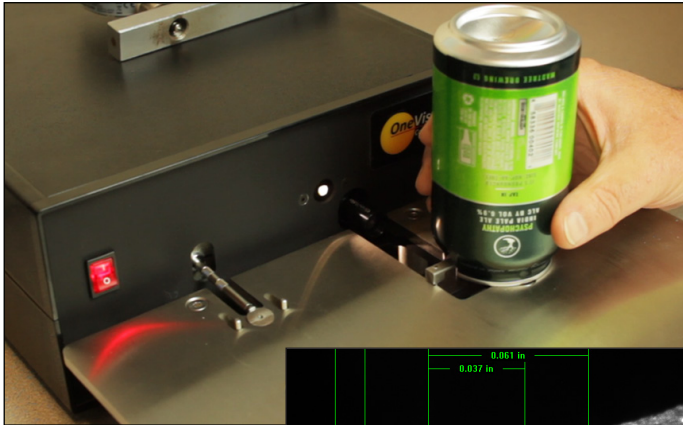
Used to visually inspect the double seam, the Model 330AT Video Module is the heart of the OneVision SeamMate® System. Driven by our proprietary software, the SeamMate System empowers you to quickly measure, store, and analyze inspection data.

Automatic Double Seam Tightness

During the inspection process, SeamMate software calculates seam tightness by analyzing the geometry of captured seam images.

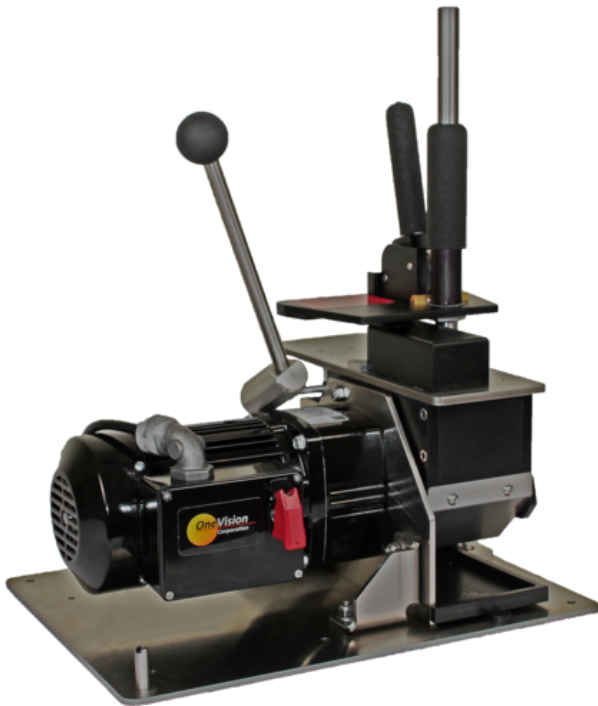
Designed for slotting aluminum cans, the Model 555 Manual Saw produces fast, clean cuts ensuring double seam measurement accuracy. One of OneVision's most durable products, the saw is low-maintenance with easy-to-change saw blades.

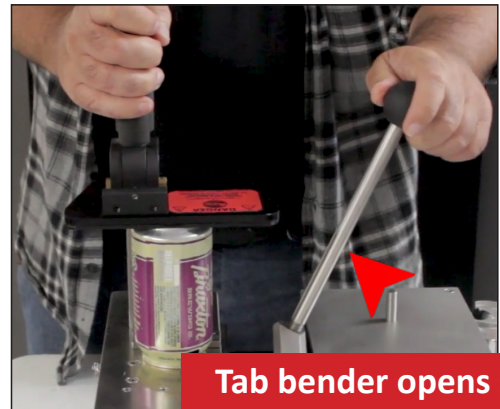
Unique tilt table design for fast cutting cycle.

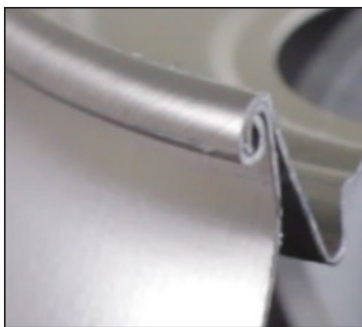
Tab bender opens slot for viewing.

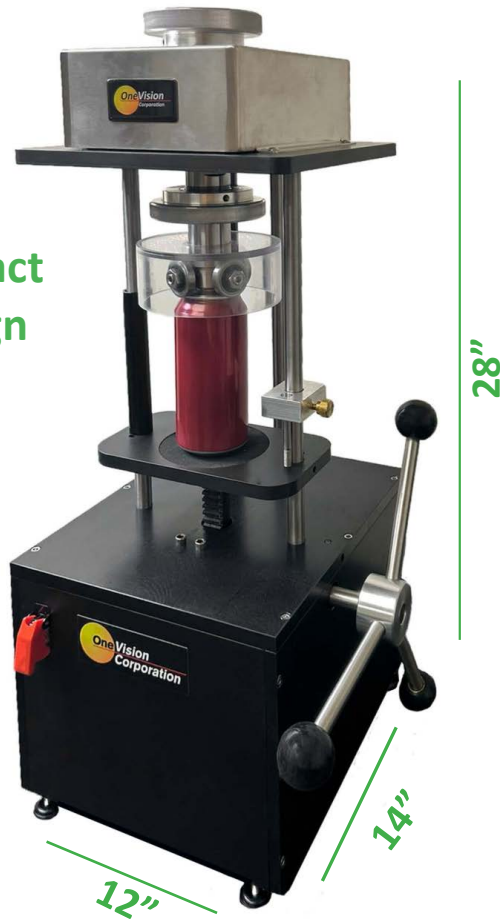
Compact
Design

Removing the cover hook by hand is difficult, time-consuming, and dangerous. The Mini Seam Stripper easily and safely removes the cover hook for tightness inspection and precise micrometer measurements.
