When Air Leaks In, Quality Leaks Out.

OneVision Corporation is a leading supplier of can seam inspection and measurement systems.

SeamMate® System bundles that meet your brewery's specific needs and budget.

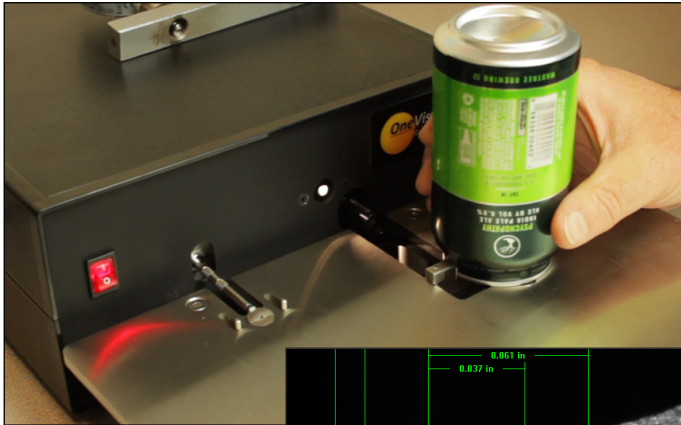
Used to visually inspect the double seam, the Model 330AT Video Module is the heart of the OneVision SeamMate® System. Driven by our proprietary software, the SeamMate® System empowers you to quickly measure, store, and analyze inspection data.

Automatic Double Seam Tightness

During the inspection process, SeamMate® software automatically calculates seam tightness by analyzing the geometry of captured seam images.

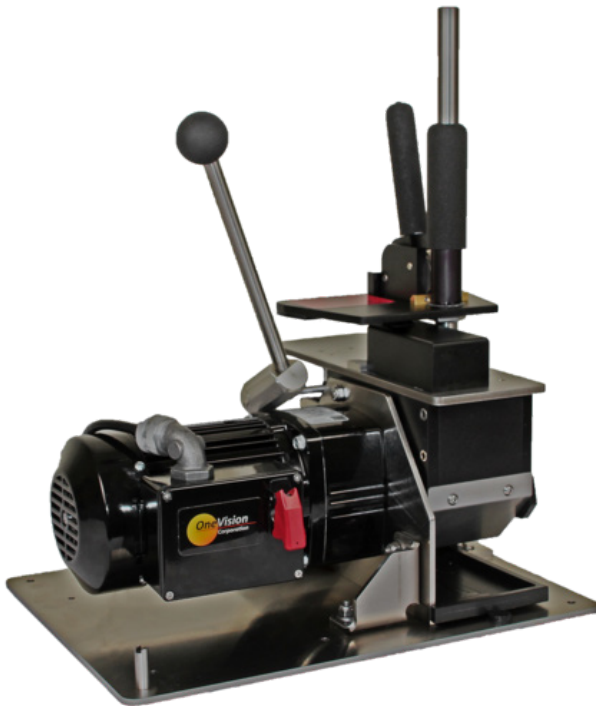
Designed for slotting aluminum cans, the Model 555 Manual Saw produces fast, clean cuts ensuring double seam measurement accuracy. One of OneVision's most durable products, the saw is low-maintenance with easy-to-change saw blades.

Unique tilt table design for fast cutting cycle.

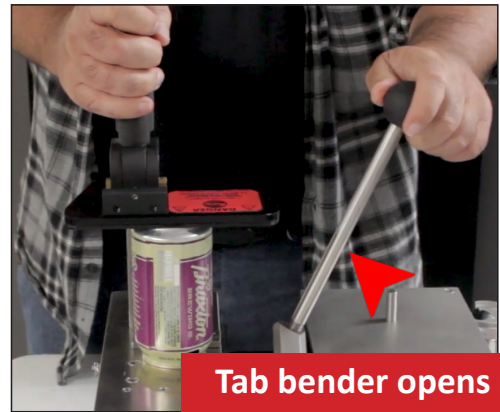
Tab bender opens slot for viewing.

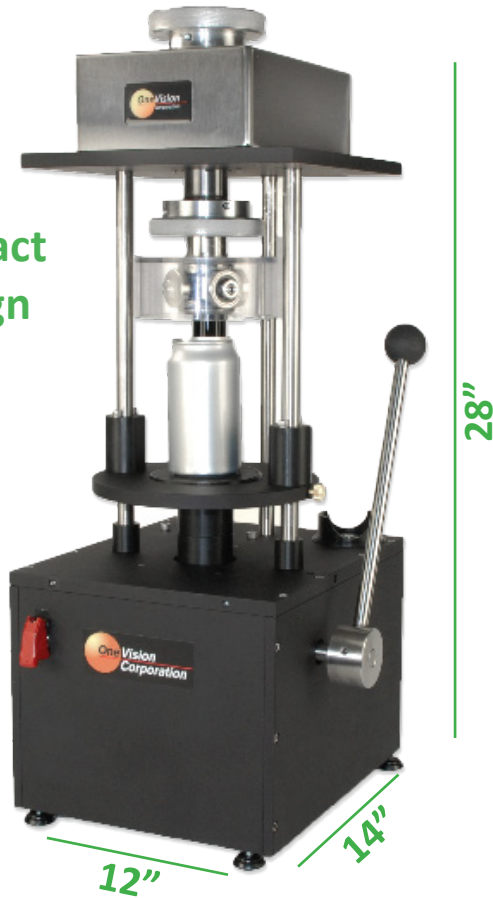
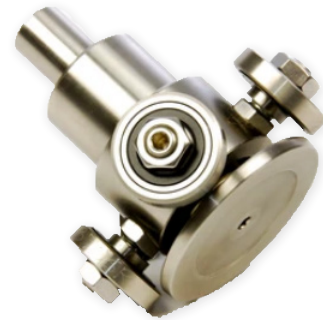
Removing the cover hook by hand is difficult, time-consuming, and dangerous. The Mini Seam Stripper easily and safely removes the cover hook for tightness inspection and precise micrometer measurements.

Includes rugged stripper head
customized to fit your cans.

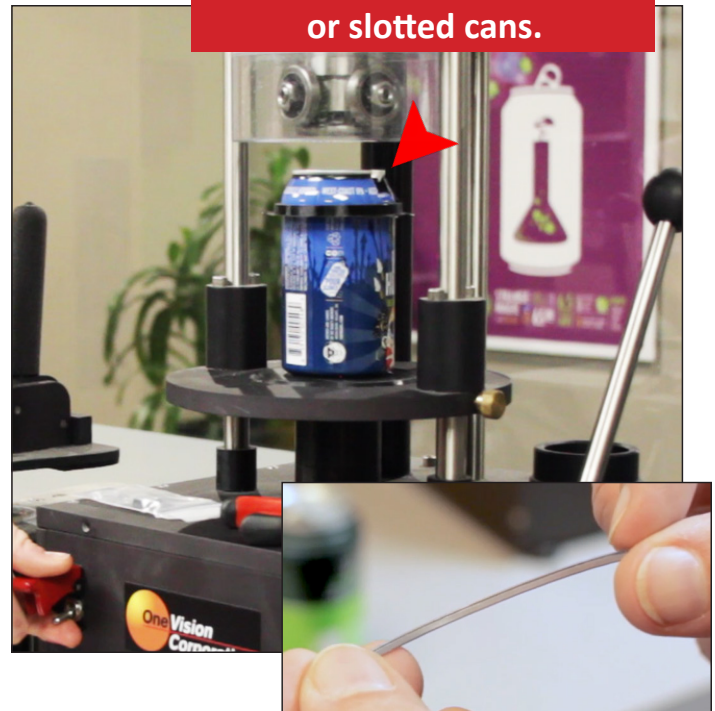
Easily strip complete seams
or slotted cans.

- Safe start/stop cutting cycle
- Quick can positioning
- Durable drive system for low maintenance
